# **Broadwater Lake**

## **An Options Report for the Ecological and Visual Improvements to the Lake**

### 1.0 Introduction

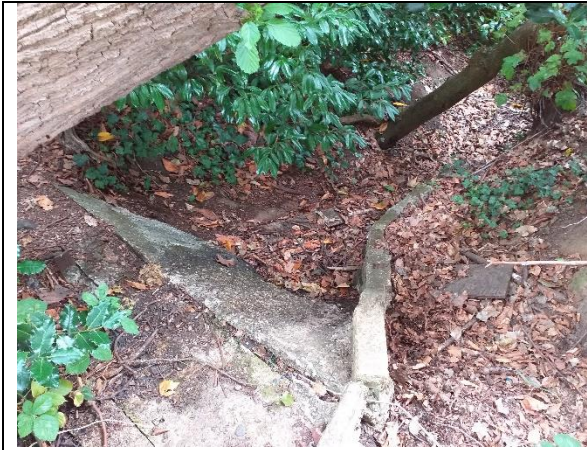
The level of the water in the lake is designed to be controlled by the spillway at the eastern end. However, there is an additional outlet under the footbridge approximately 80m west of the eastern end on the northern bank. The invert of this outlet is indicated to be lower than the spillway and indeed water was seen flowing out of this second outlet and under the footbridge whilst it was dry at the main eastern

Fig 6: Dry Spillway at the eastern end of the lake

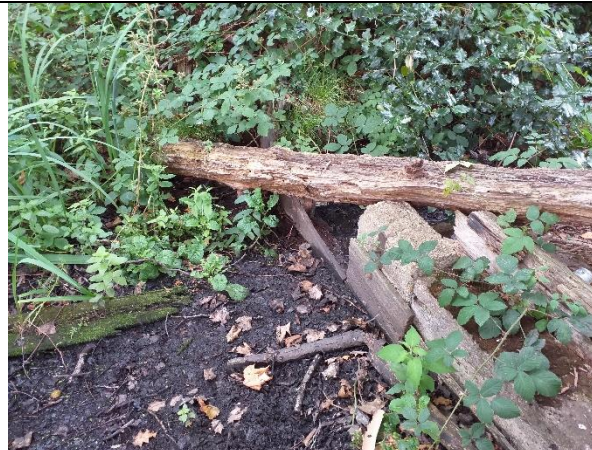
Fig 7: Debris and broken concrete on the spillway

The condition of the spillway is very poor with broken concrete and debris laying across the crest and it is therefore recommended that this is fully repaired with a crest height that reflects the required water level of the lake.

There is a considerable build-up of silt in front of the spillway, which has also caused the lake water to divert to the footbridge outlet. This will need to be removed by dredging and is dealt with in more detail in the following sections.

The level of the outlet under the footbridge will likely required to be raised to ensure that the eastern spillway is the governing structure for the lake water level.

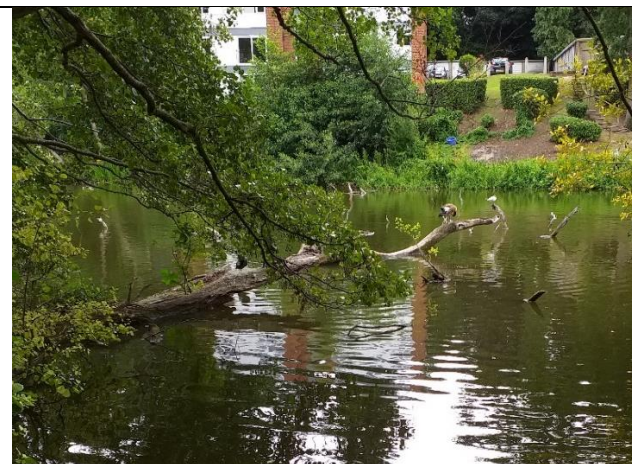
Fig 8 above: An example of a fallen tree used by birds and Fig 9 right, where a fallen tree should perhaps be removed.

The example provided in the photos above left shows a fallen tree used frequently by birds for diving for food, drying and resting. The second photo shows a fallen tree that is likely to be a navigation issue for small boats and possible dredging works.

This is perhaps a matter for discussion with the various stake holders with the final choice being associated with future viewing points, navigation needs, dredging requirements and maintenance.

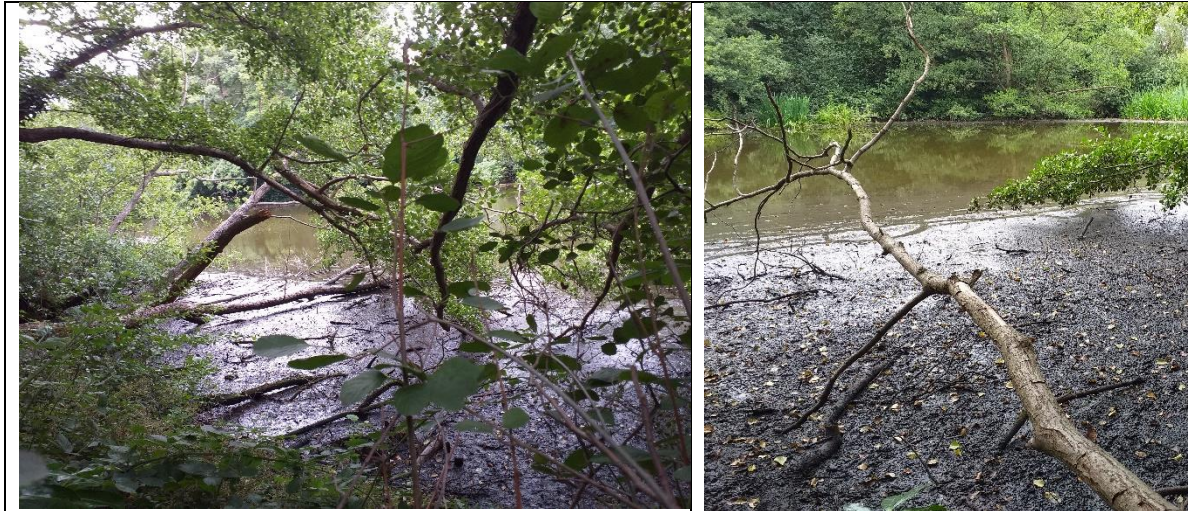
Figs 10 and 11 showing trees fallen into the mud in areas where diving birds could not operate.

The photos in Figs 10 and 11 shows a series of small trees that have fallen into the mud and would ideally be removed allowing the area to be dredged and the bank reinstated.

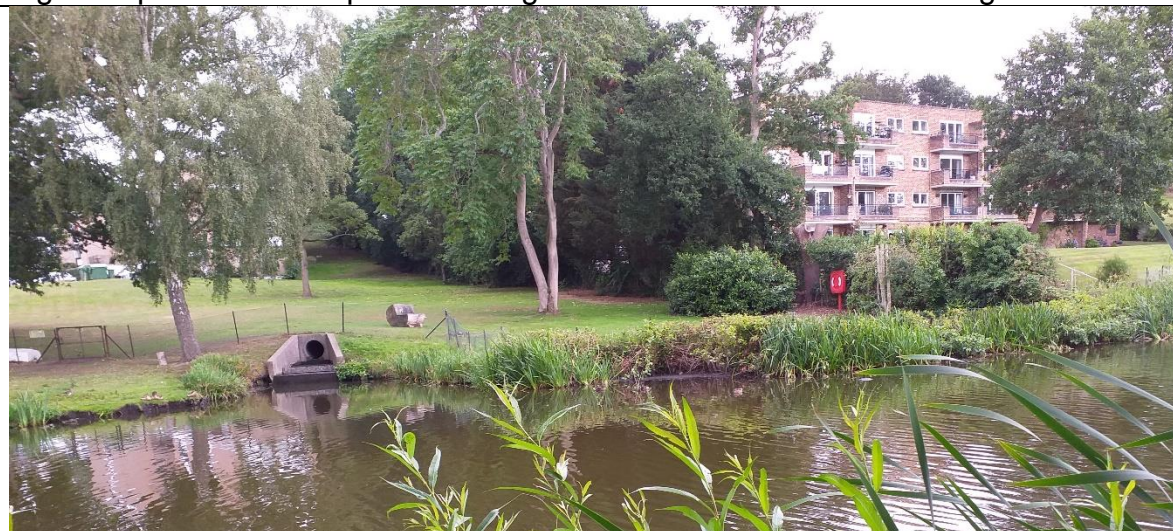
Fig 13: Isolated sections of aquatic plants on the south bank where shallow water permits

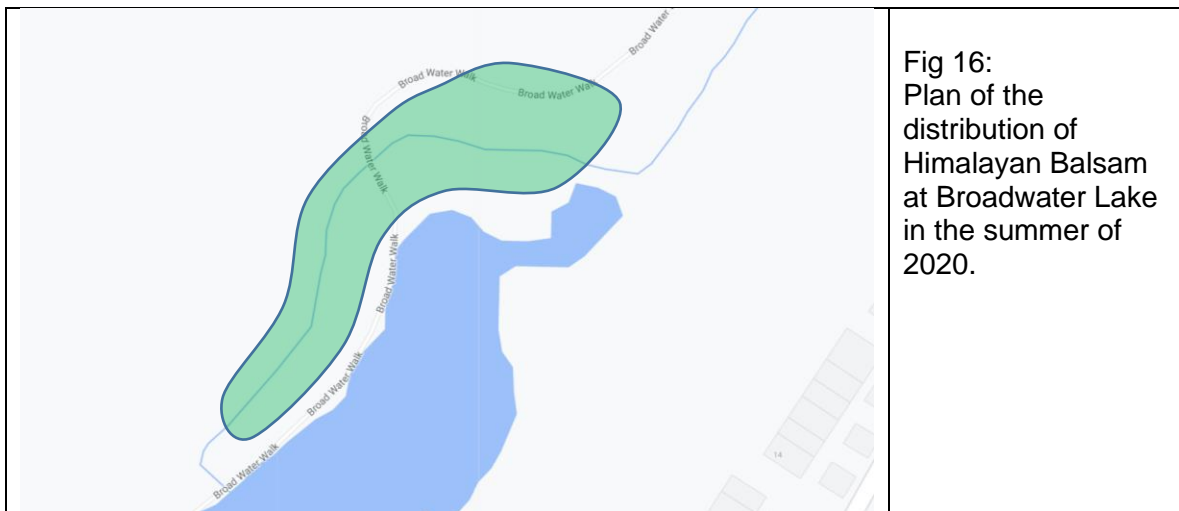
During the walkover survey of the site, a significant area of Himalayan Balsam was identified at the western end on the north bank as illustrated in Fig 16 below. Himalayan Balsam is listed in Schedule 9 of the Wildlife and Countryside Act 1981 as an invasive plant species. It is prevalent around water bodies and spreads very easily when its seed pods burst in the late summer.

Fig 16:  
Plan of the  
distribution of  
Himalayan Balsam  
at Broadwater Lake  
in the summer of  
2020.

Although it is not a notifiable plant and landowners are not obligated to eradicate it, they are not allowed to let it spread. Fortunately Himalayan Balsam can be easily and safely controlled by pulling out the plants, or cutting below the first node, preferably in May or June before they seed. The roots are shallow and in soft moist ground the plants can be readily pulled. Once pulled, the plants will decompose and, provided that seeds have not developed, can be composted.

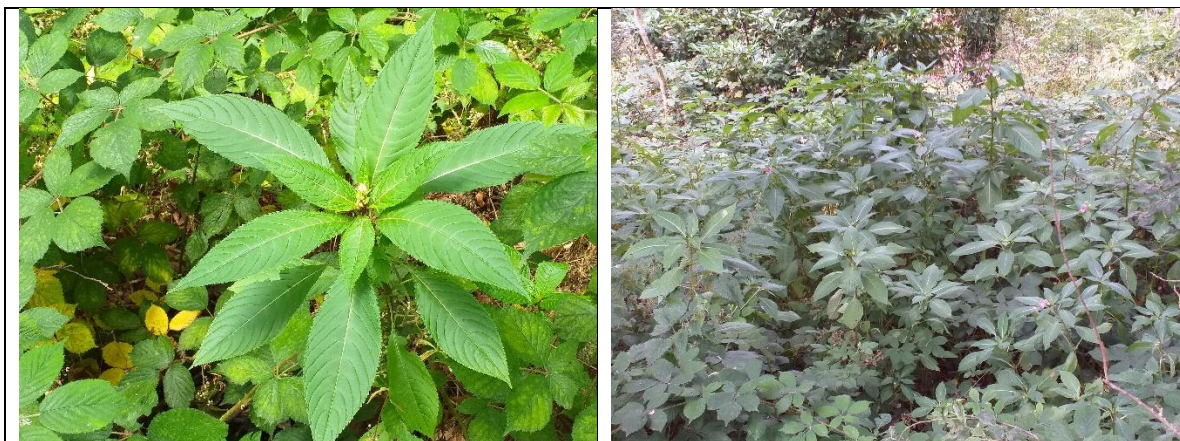
The plants are readily identifiable from their foliage as seen in the photos below and if allowed to flower will have a purplish pink trumpet like flower which will develop into a seed pod. These seed pods can explode spreading the seed up to 4.0m from the original plant and thus spreading rapidly in the right conditions.

Figs 17 and 18: Photos of Himalayan Balsam at Broadwater Lake

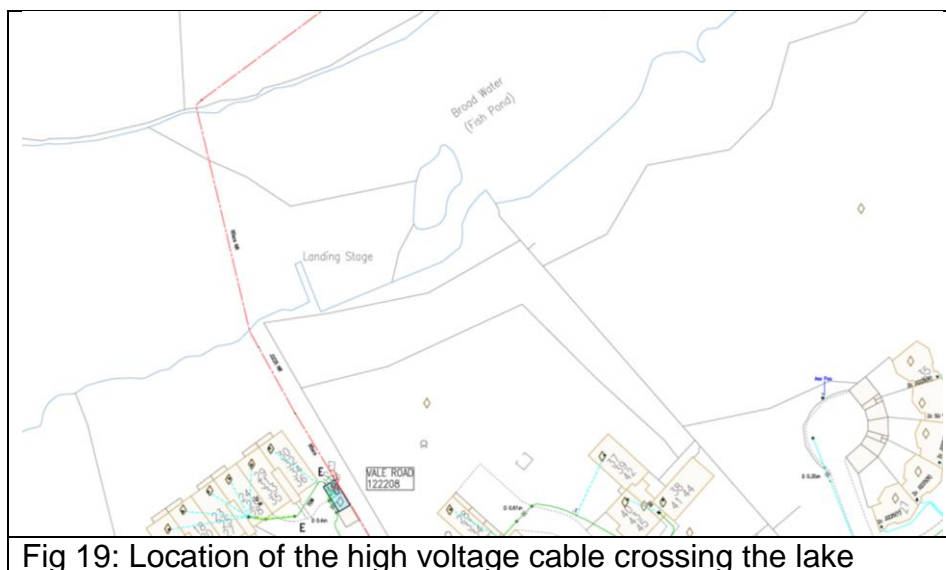
However, it is known that there is a 11,000 volts cable crossing the lake approximately halfway along that might affect the proposed dredging regime and the position of this is shown on the plan below and is reflected in the marked up dredging plans in the appendices.

Fig 19: Location of the high voltage cable crossing the lake
