# **Broadwater Lake**

## **An Options Report for the Ecological and Visual Improvements to the Lake**

### 1.0 Introduction

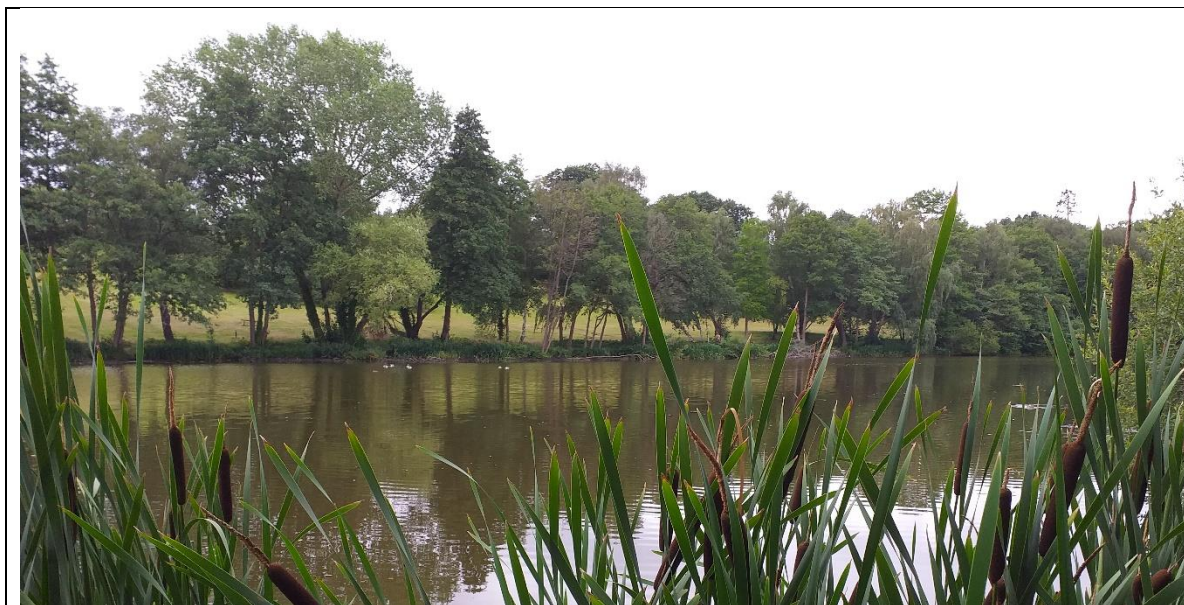
The banks to the south are largely laid to grass being the gardens of houses or other private properties. A variety of individual specimen trees have been planted along the top of the bank in front of the hotel which may have form part of the original estate design – see Fig 12. Some occasional aquatic planting can be seen elsewhere along the bank where water depths allow as seen in Fig 13 below.

Fig 12: Specimen trees planted along the southern bank in the hotel grounds

Except perhaps to remove some the reed beds and substitute them for species that will not spread so readily, it is not proposed to carry out and significant changes to the southern bank. There are many individual landowners along the bank, and each may have their own ideas and it would therefore be useful if their wishes were

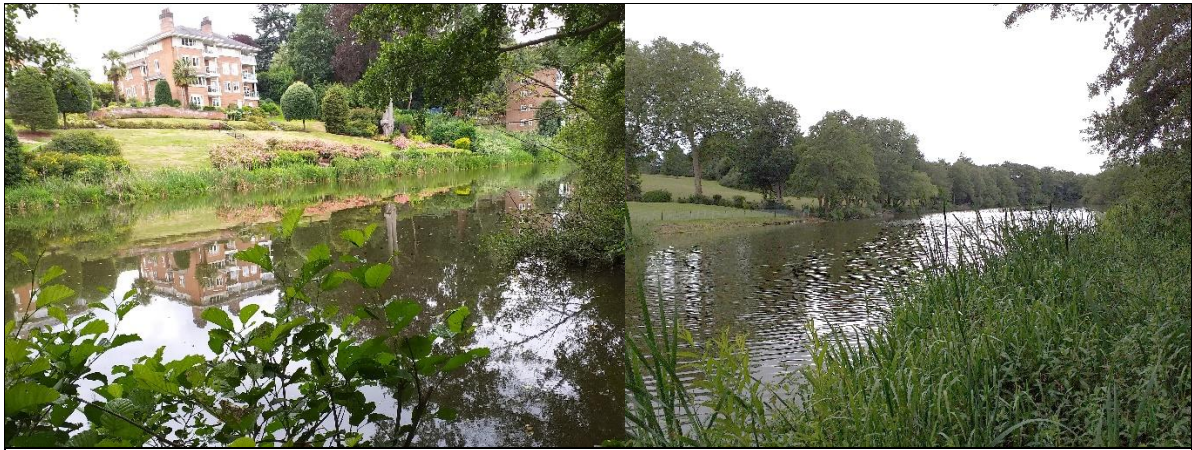
Figs 14 & 15: Possible locations for future viewpoints

It is therefore proposed that a number of locations are identified in consultation with interested parties, that are developed as viewpoints. A limited number of trees may need to be cleared, or at least some branches to facilitate the view. It is suggested that a harder lake edge is constructed in timber to prevent persons accidentally walking into soft mud or deeper water and a gravel area established perhaps with a seat.
